AERIAL PHOTOGRAPHIC ANALYSIS OF SELECTED HAZARDOUS WASTE STUDY SITES

New Mexico and Texas

EPA Region VI

TS-AMD-82110a
April 1983

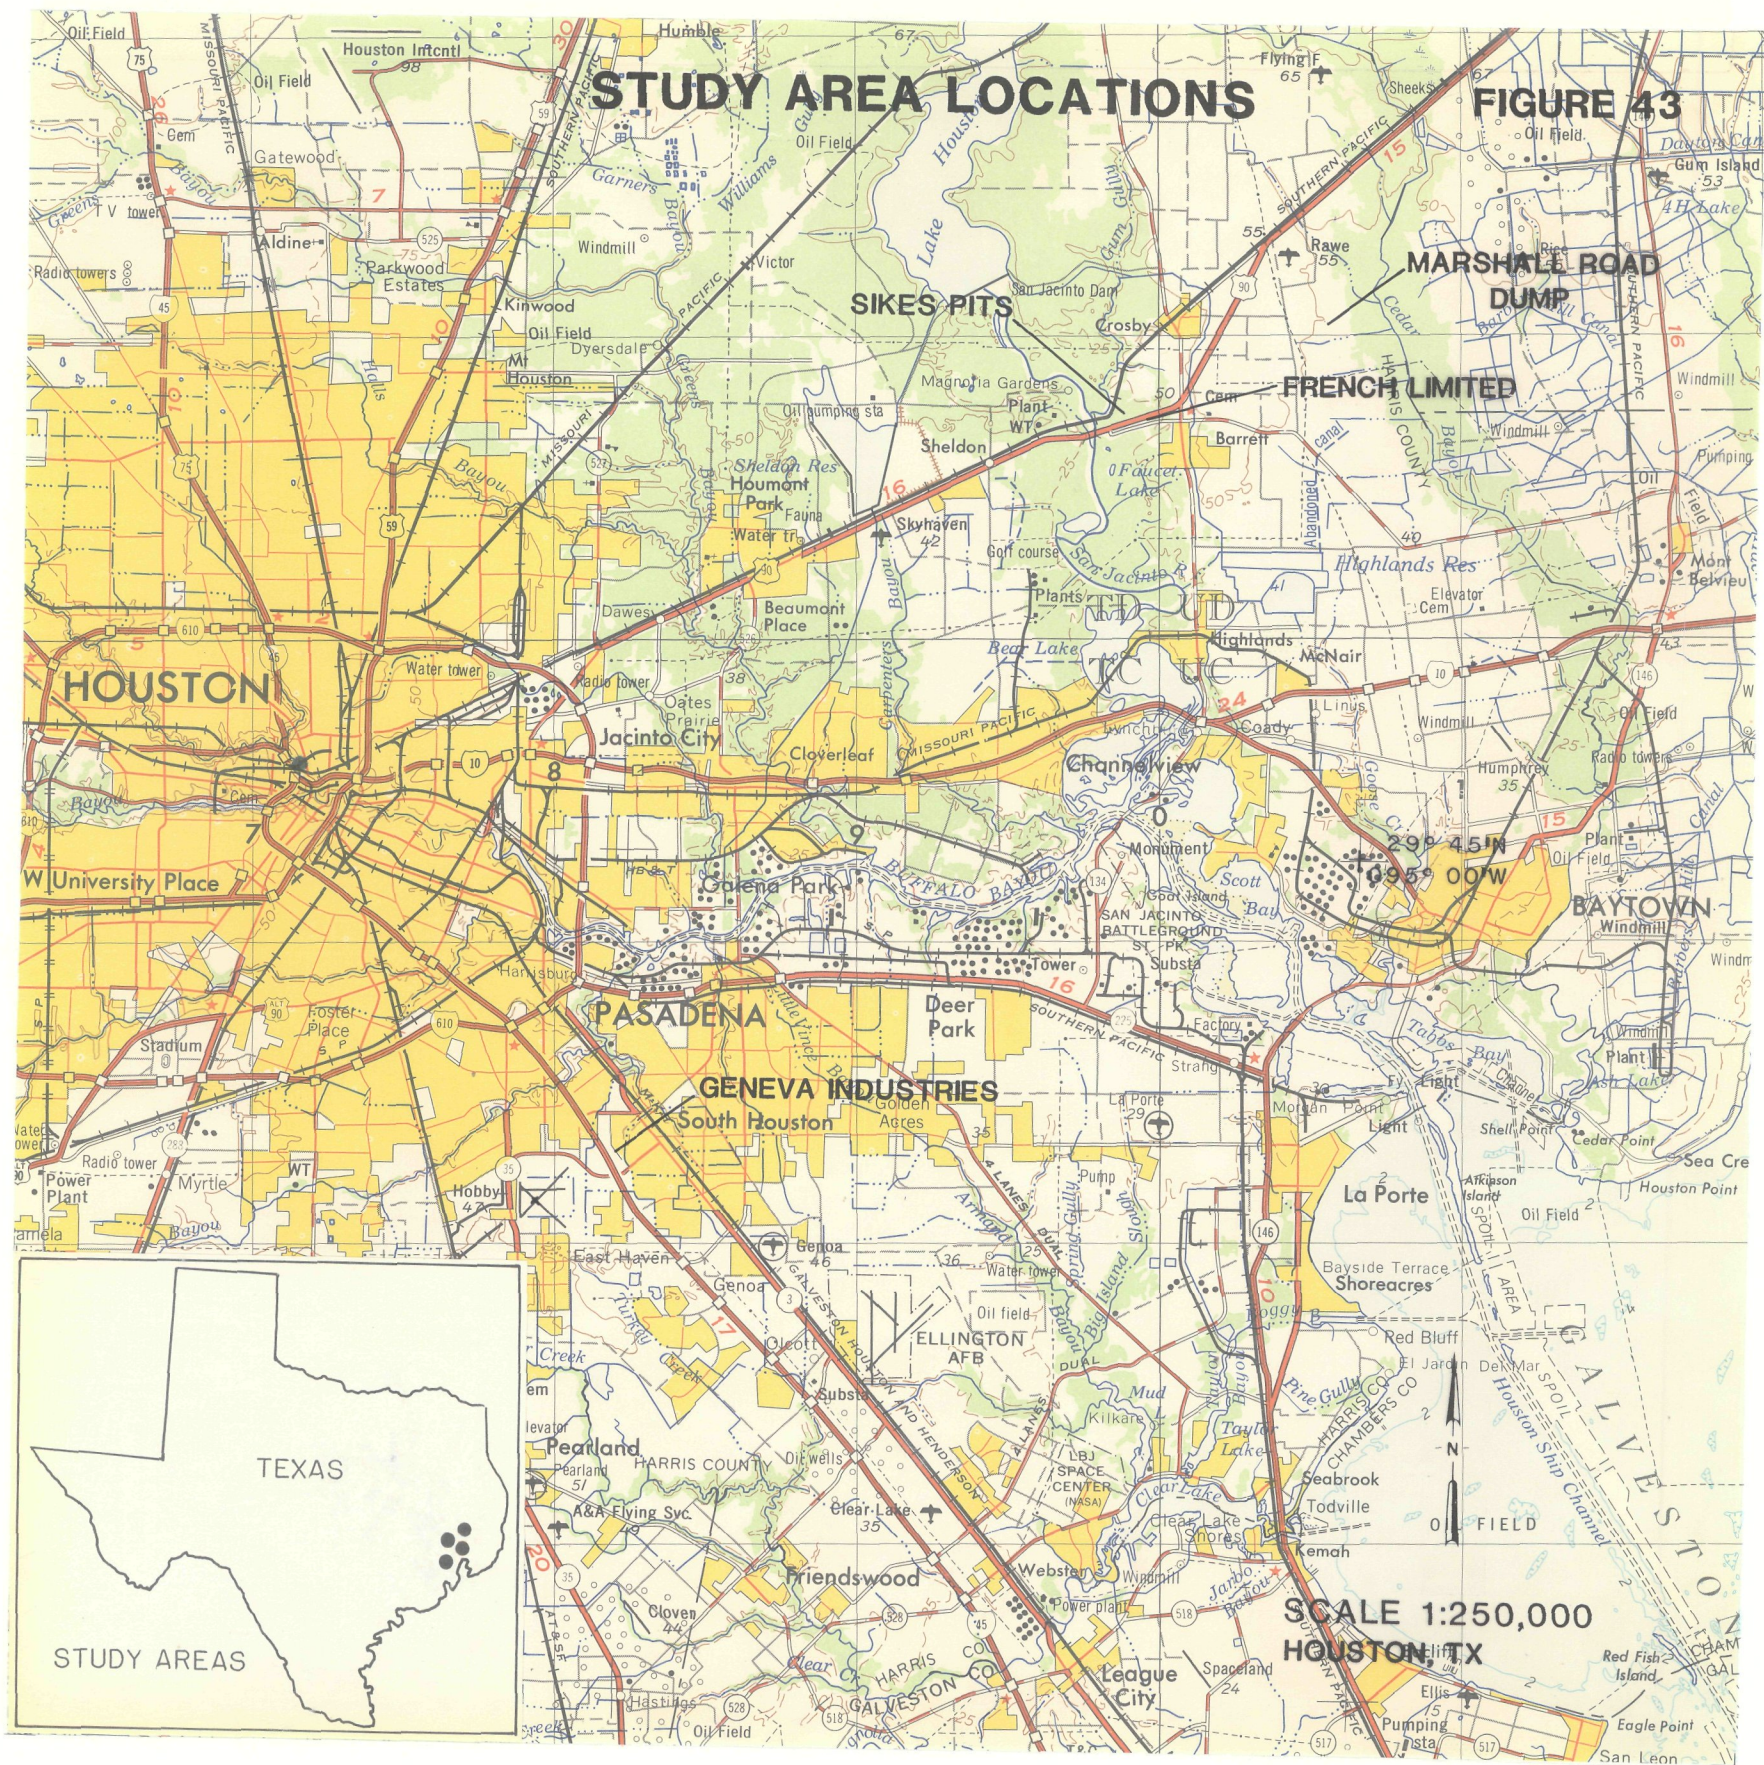
Considerable vegetative stress is apparent within a fenced area that is located east of the drum concentration. Several drums are visible within the enclosure. Accumulations of liquid were present within the area on May 10, 1982, but the area is dry on this photo. Solid waste dumps are visible here as well as elsewhere within the site.

A large burn area is noted northwest of the Marshall Road Dump. No evidence of burning was apparent on the May 10, 1982, photograph.
